RE: Milliken and Company – Hillside Plant
LaGrange, Troup County, Georgia
Site Inspection Report

SITE INSPECTION

**MILLIKEN & COMPANY – HILLSIDE PLANT
LAGRANGE, TROUP COUNTY, GEORGIA
GAD 981 275 993**

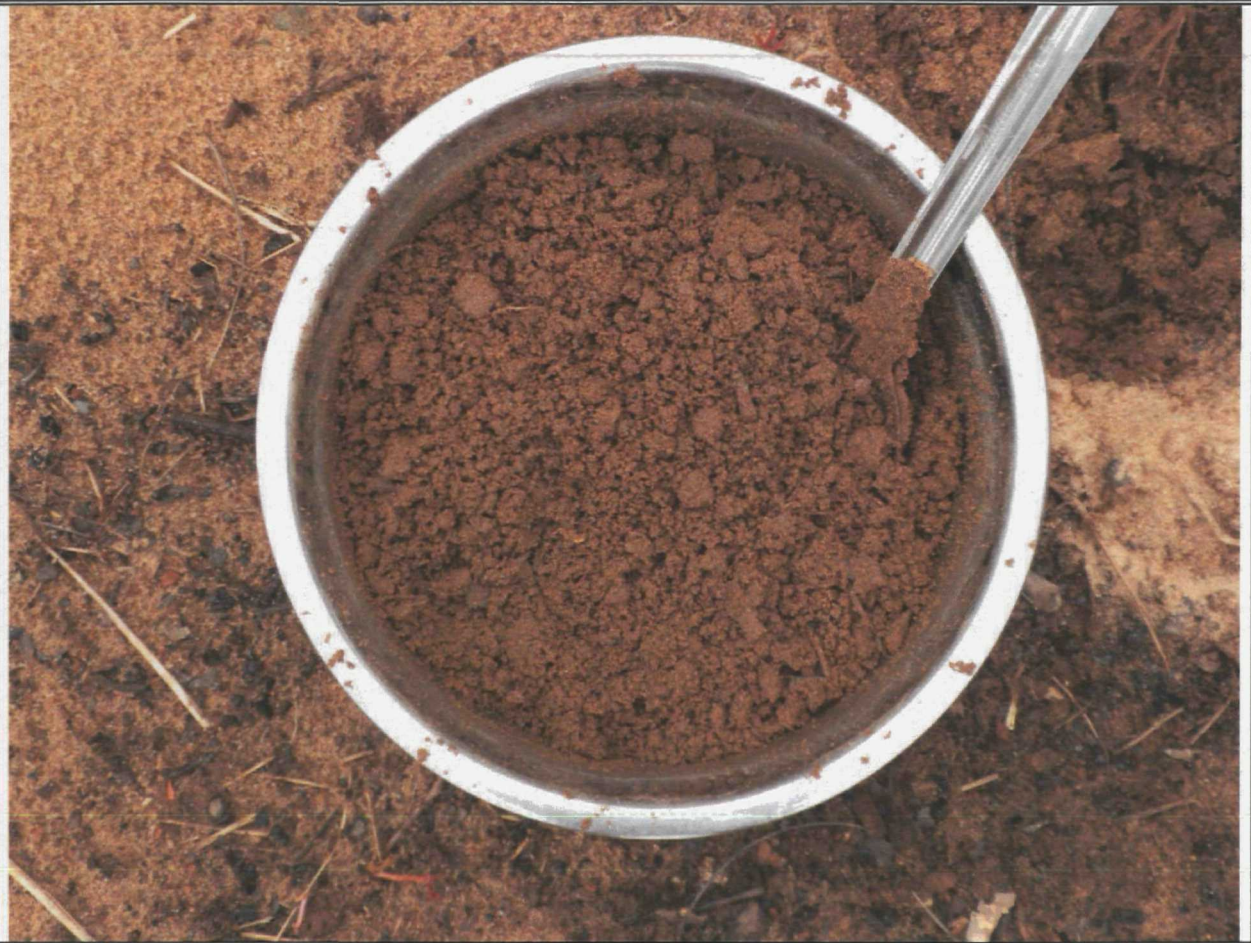
Depiction of surficial soil sample matrix collected from off-site Sample Station No. STA-21-SS (HW11004).

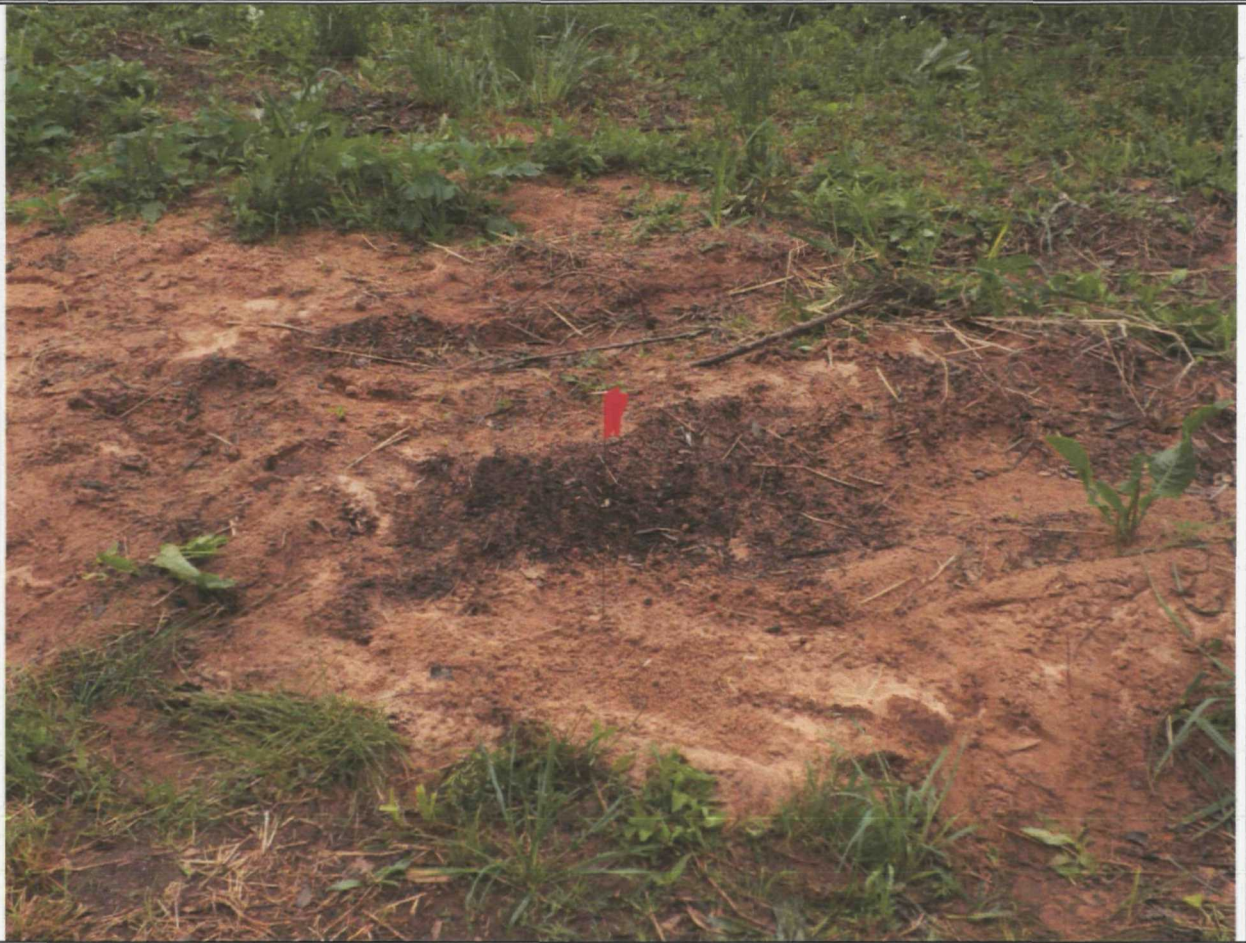
Depiction of immediate vicinity of off-site Sample Station No. STA-21-SS (HW11004).

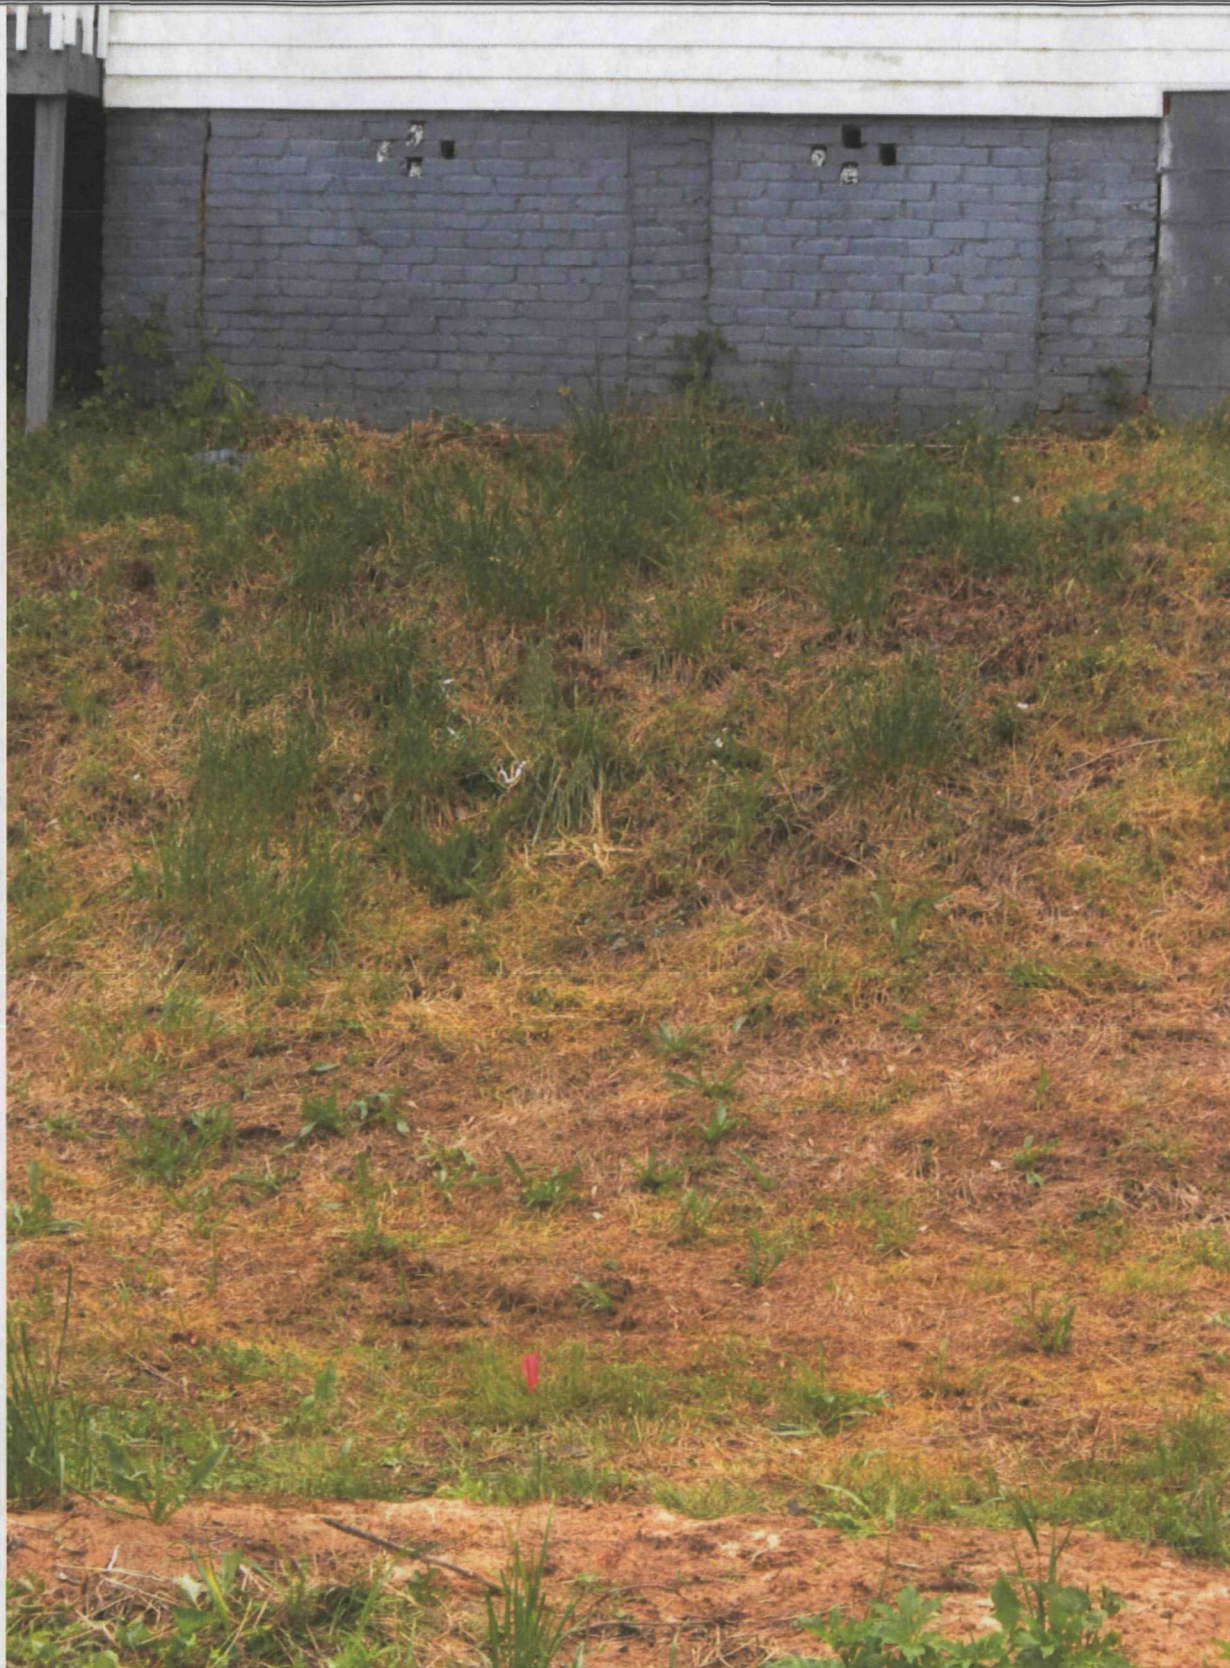
Depiction of general vicinity of off-site Sample Station No. STA-21-SS (HW11004). This sample station is located on contiguous residential property immediately west of the site [approximately thirty (30) feet from the depicted residential structure].

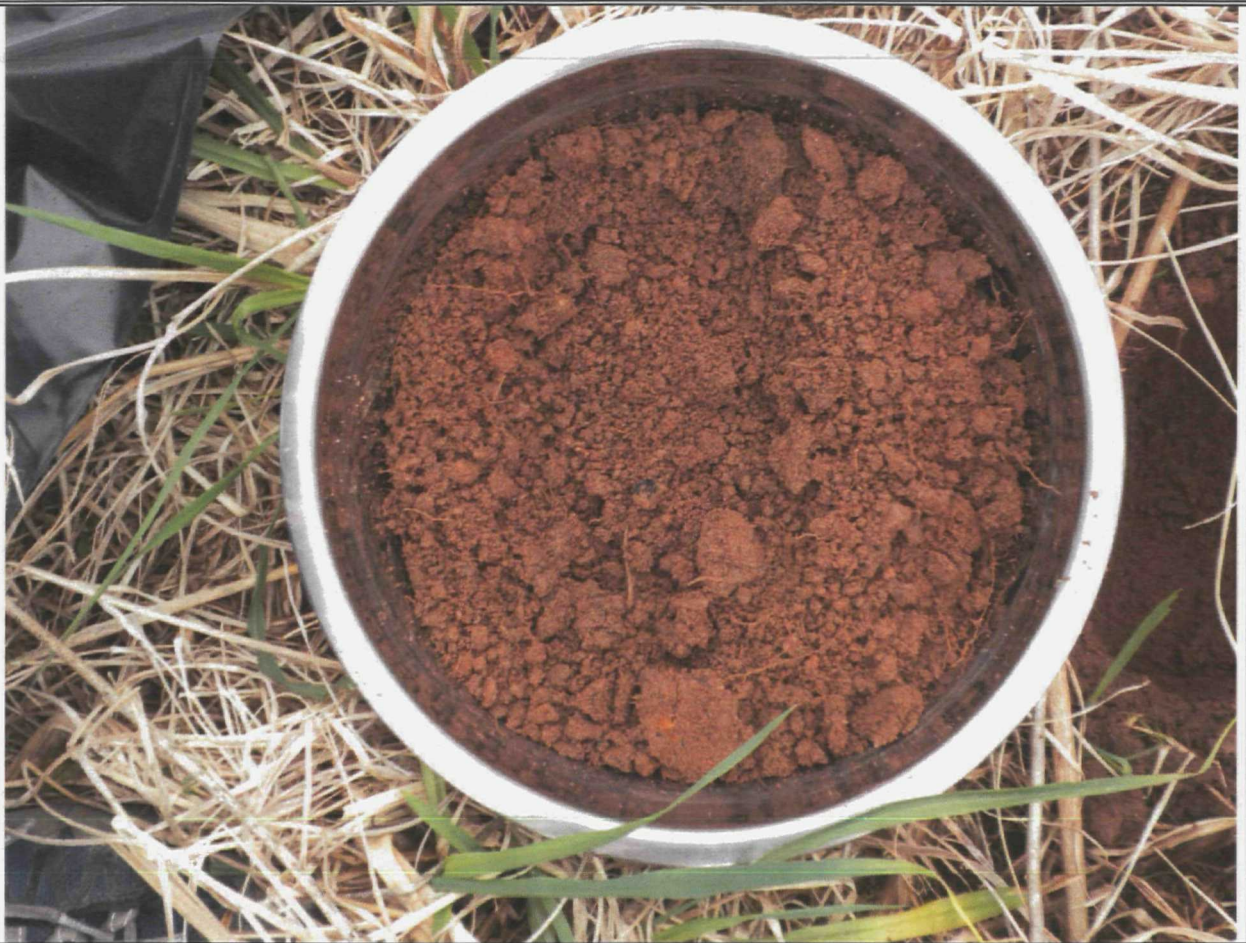
Depiction of surficial soil sample matrix collected from off-site Sample Station No. STA-23-SS (HW11006).

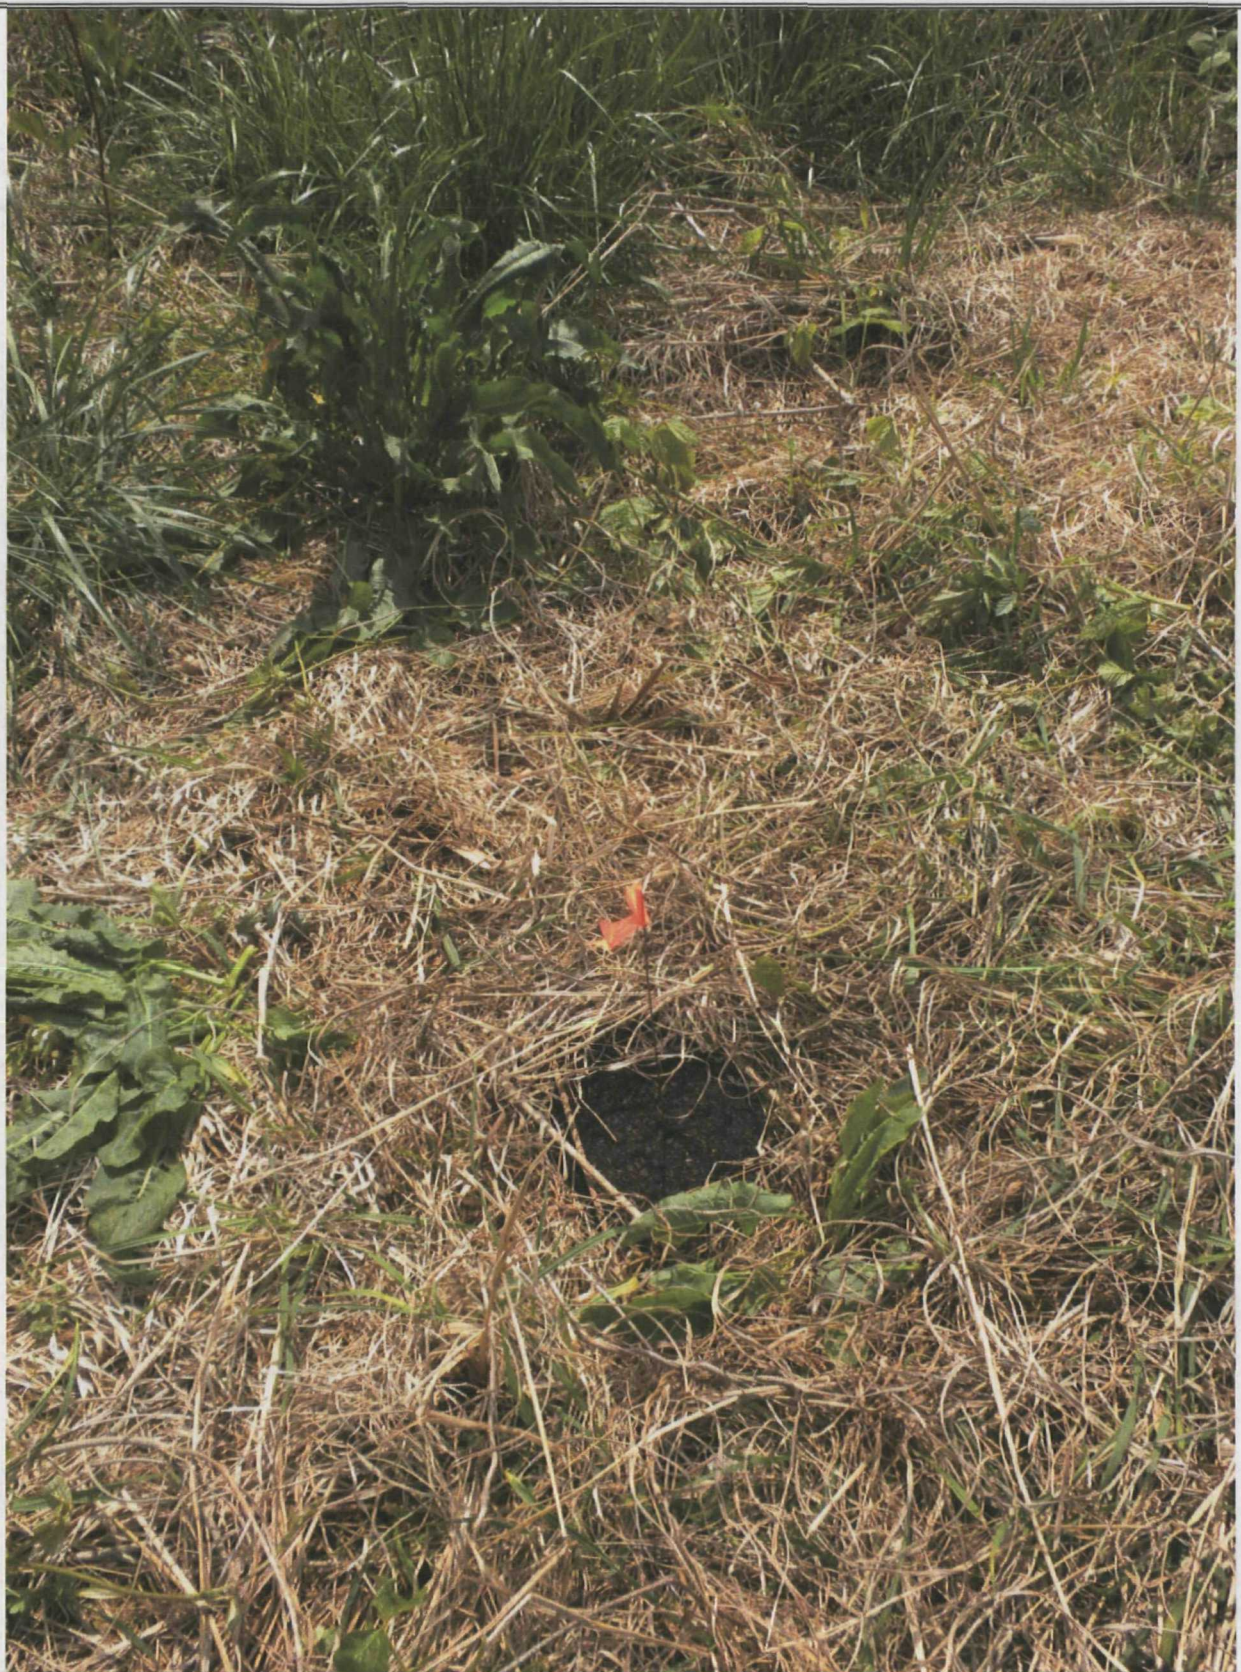
Depiction of immediate vicinity of off-site Sample Station No. STA-23-SS (HW11006).

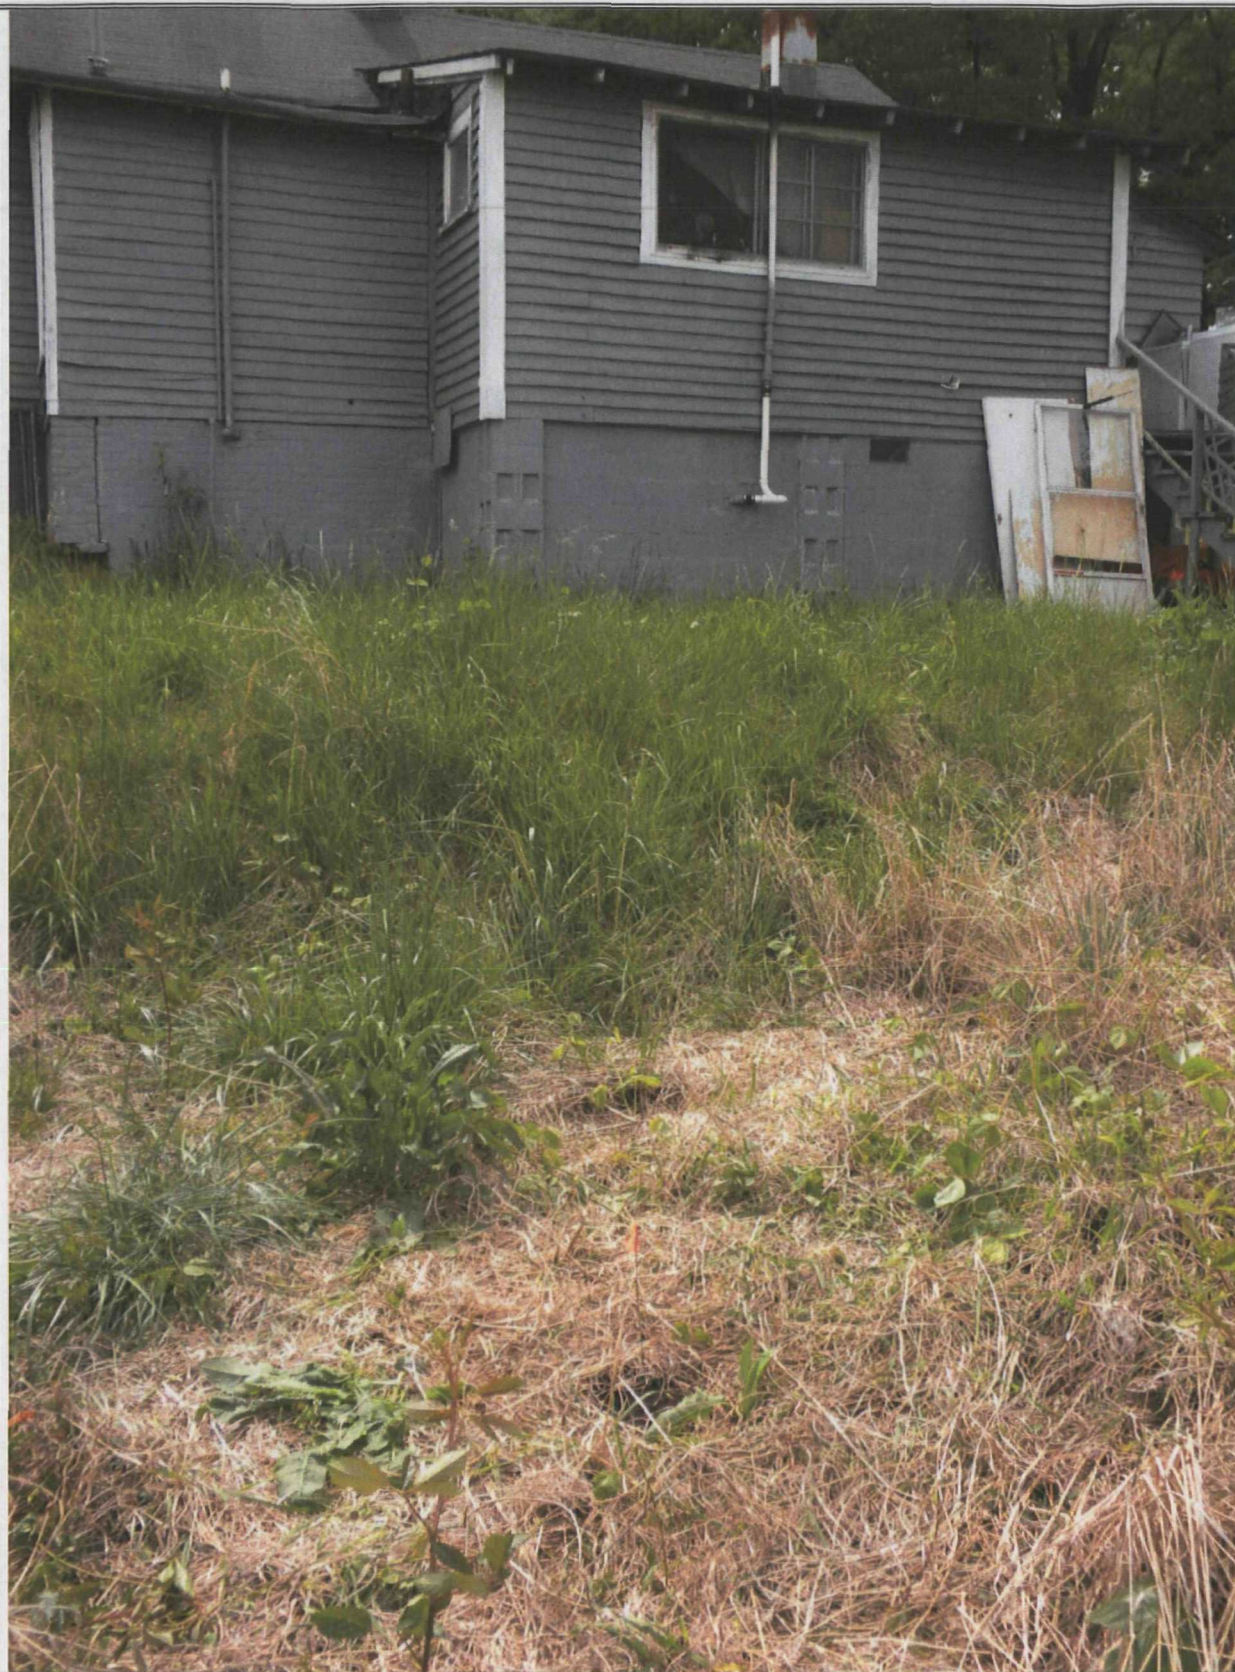
Depiction of general vicinity of off-site Sample Station No. STA-23-SS (HW11006). This sample station is located on contiguous residential property immediately west of the site [approximately thirty-seven (37) feet from the depicted residential structure].

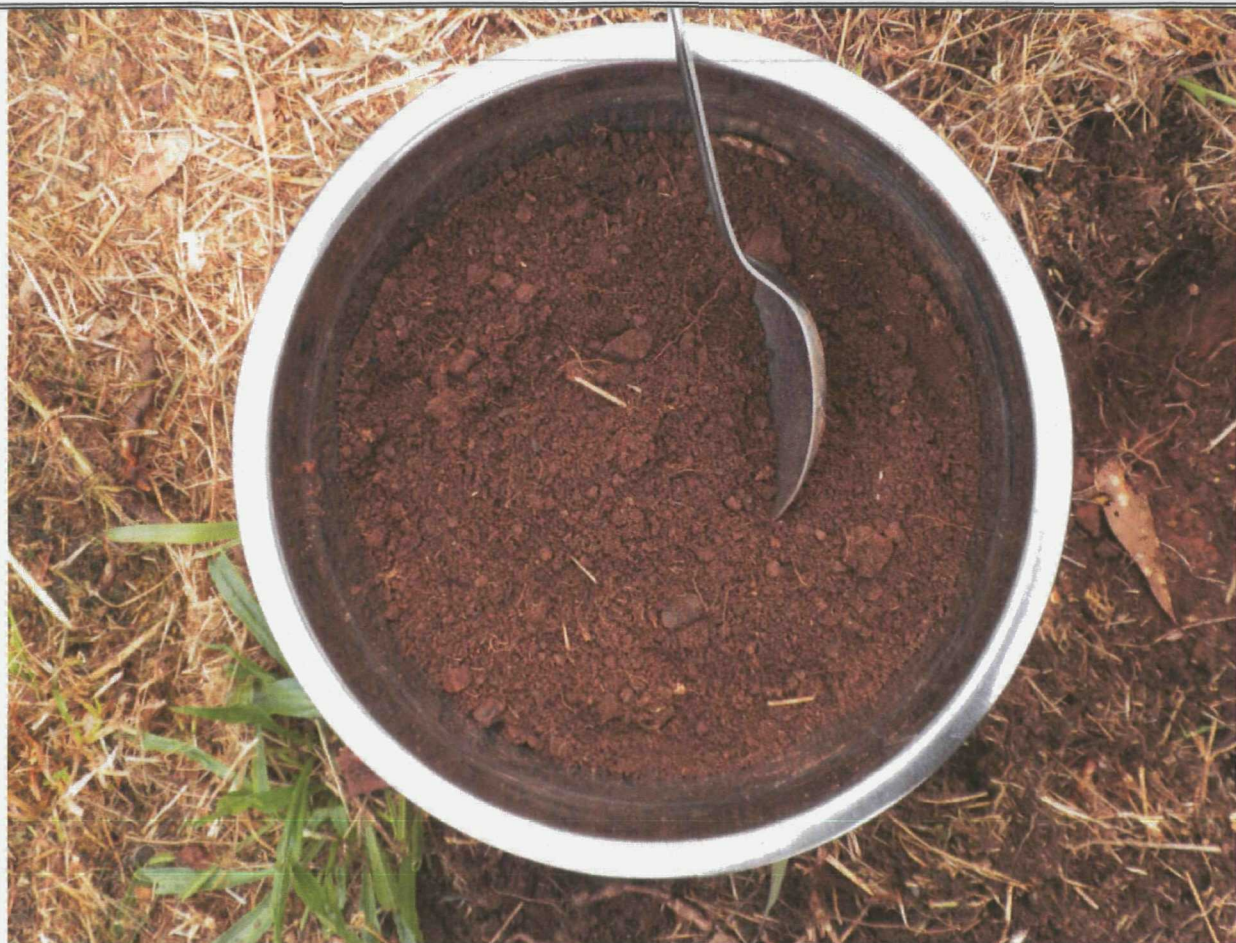
Depiction of surficial soil sample matrix collected from off-site Sample Station No. STA-25-SS (HW11009).

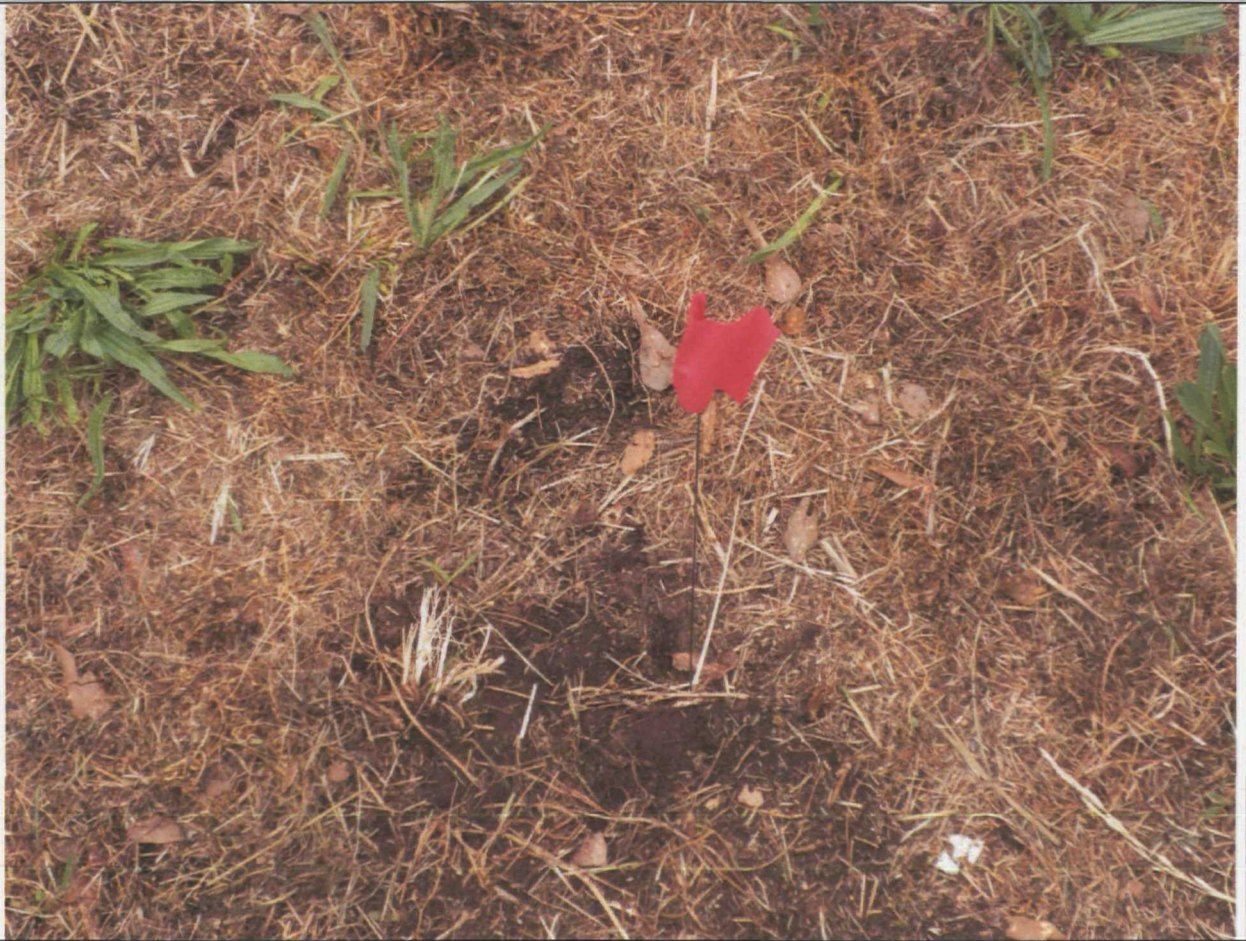
Depiction of immediate vicinity of off-site Sample Station No. STA-25-SS (HW11009).

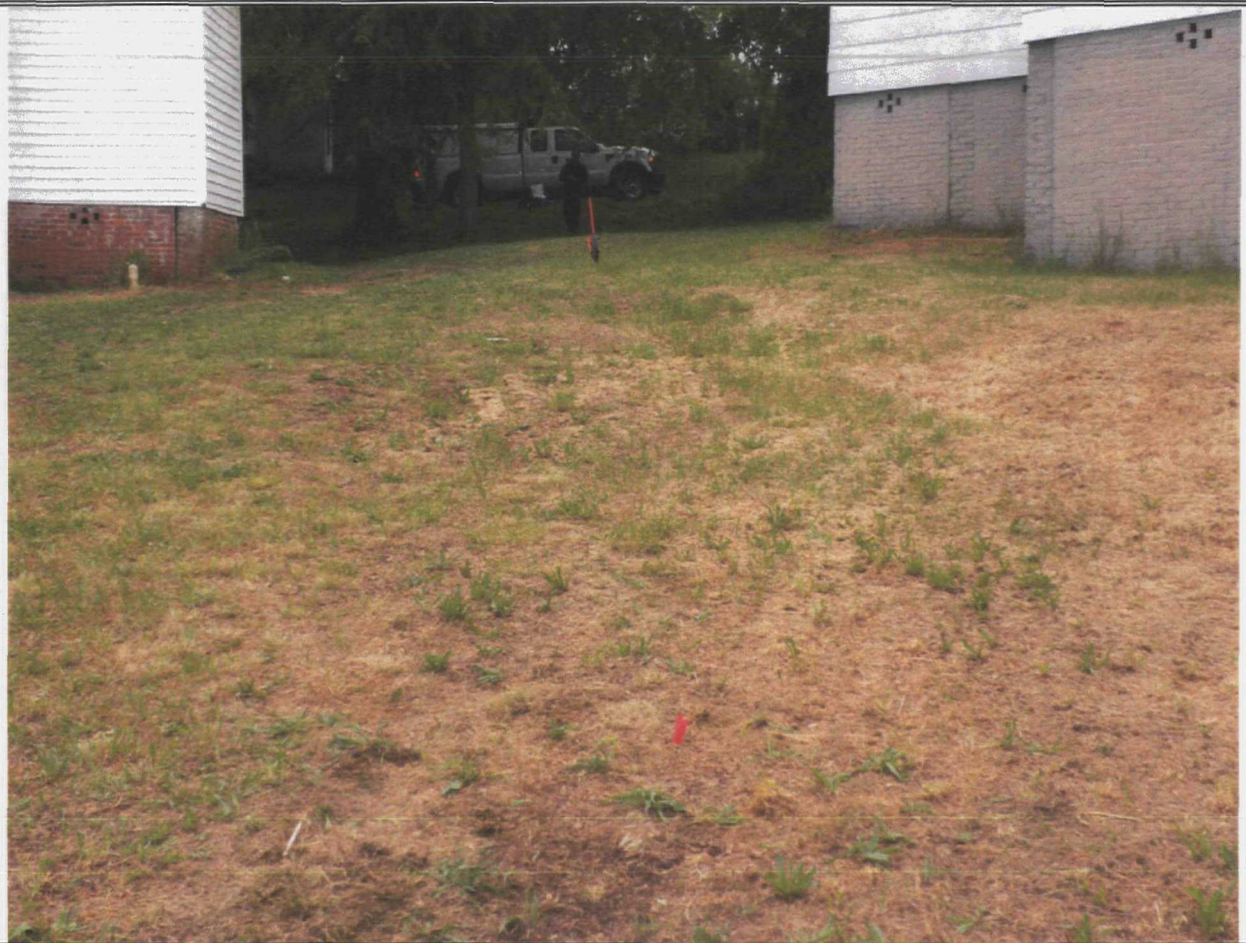
Depiction of general vicinity of off-site Sample Station No. STA-25-SS (HW11009). This sample station is located on contiguous residential property immediately west of the site [approximately fifty-six (56) feet from the depicted residential structure at left, approximately forty-two (42) feet from the depicted residential structure at right].

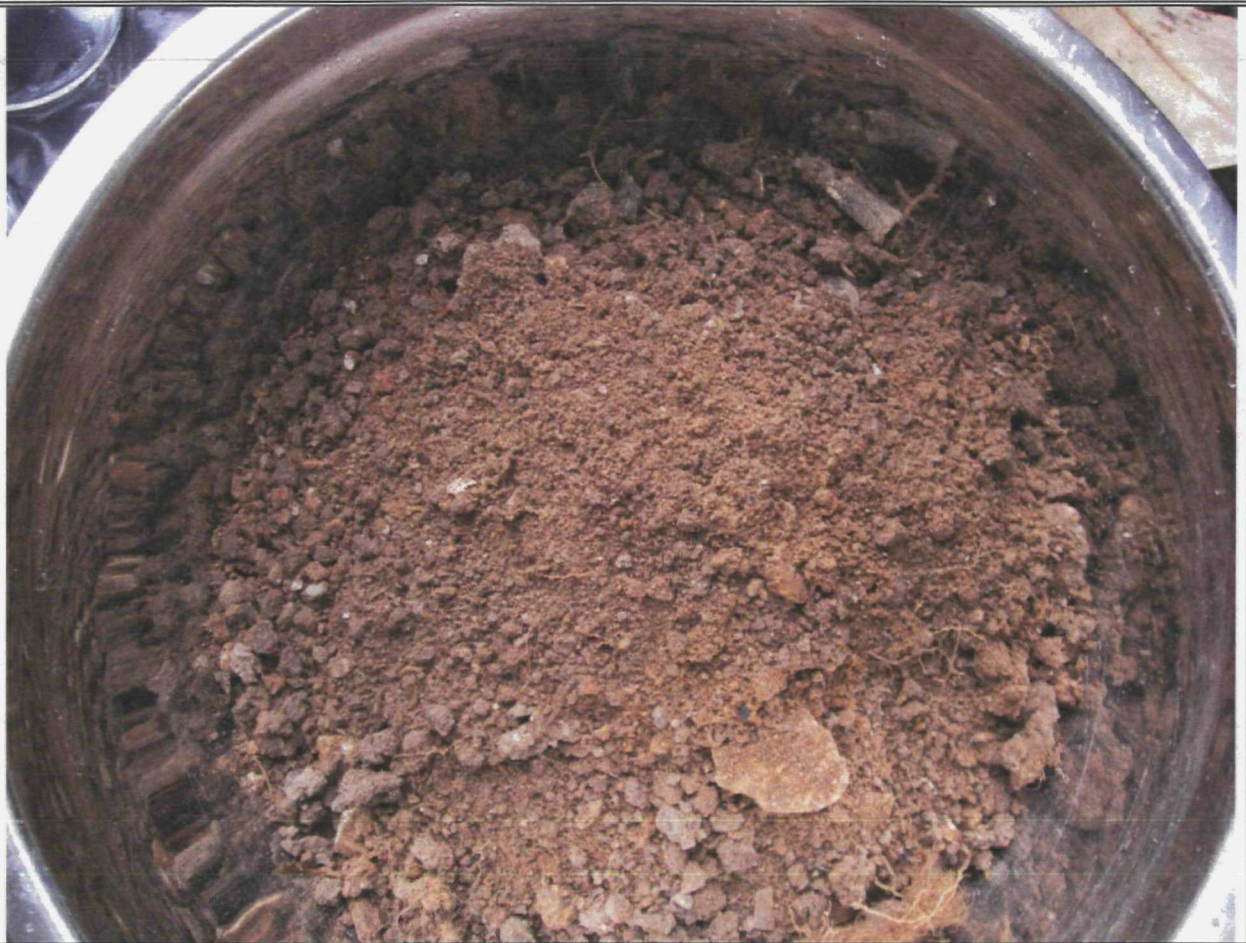
Depiction of surficial soil sample matrix collected from on-site Sample Station No. STA-27-SS (HW11012).

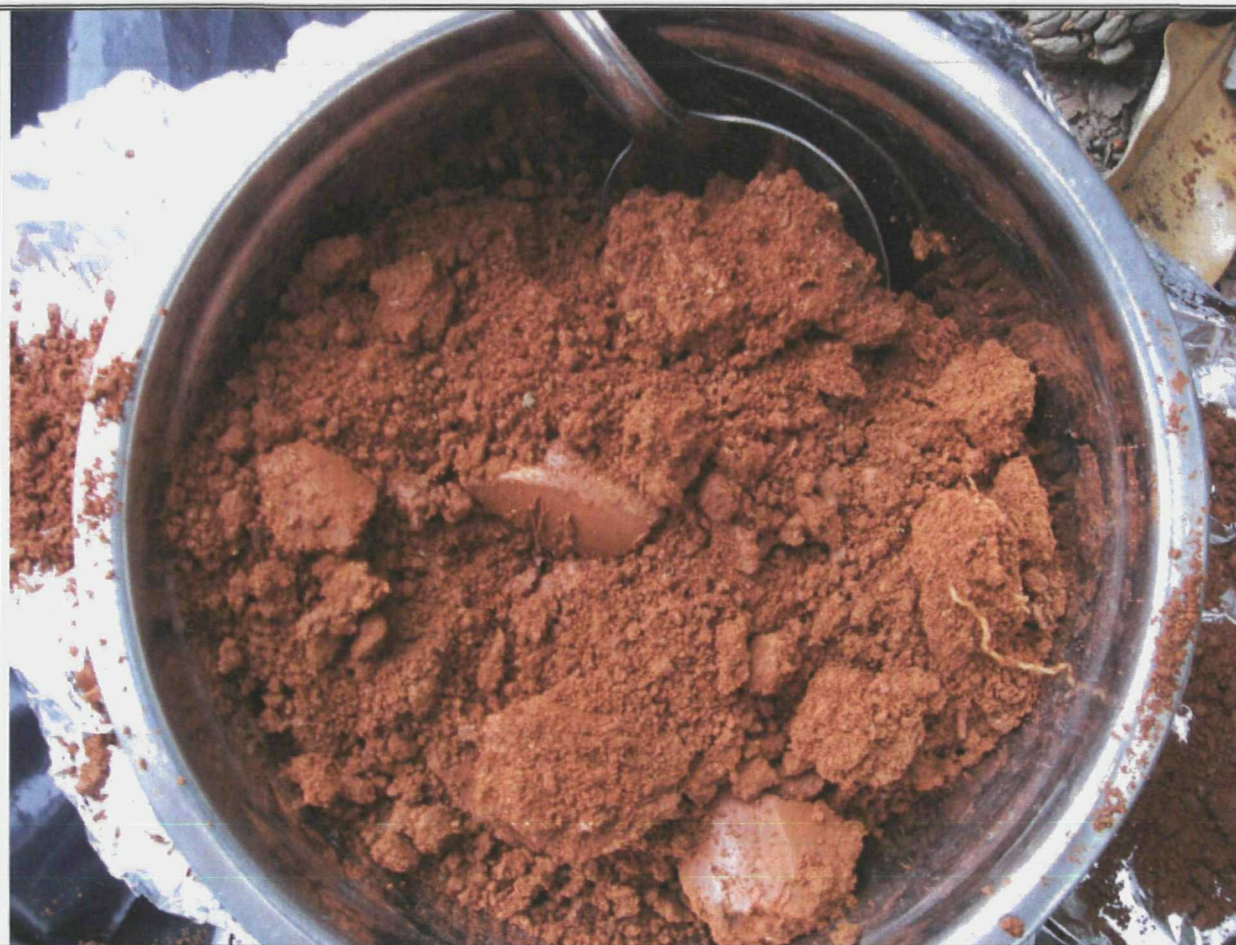
Depiction of subsurface soil sample matrix collected from on-site Sample Station No. STA-27-SUB (HW11013).

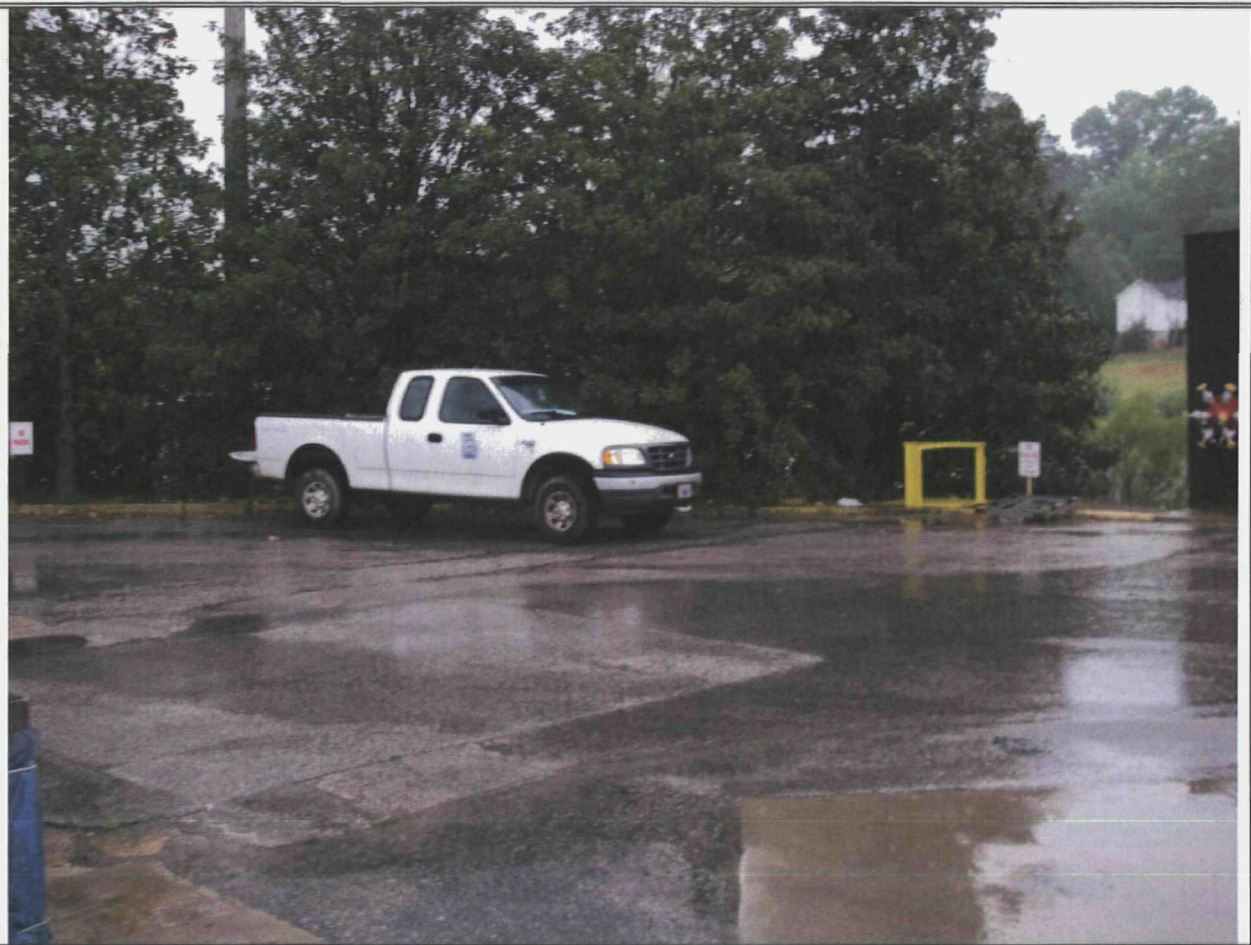
Depiction of general vicinity where surficial soil and sub-surface soil samples were collected from on-site Sample Station Nos. STA-27-SS and STA-27-SUB respectively (HW11012 and HW11013 respectively).

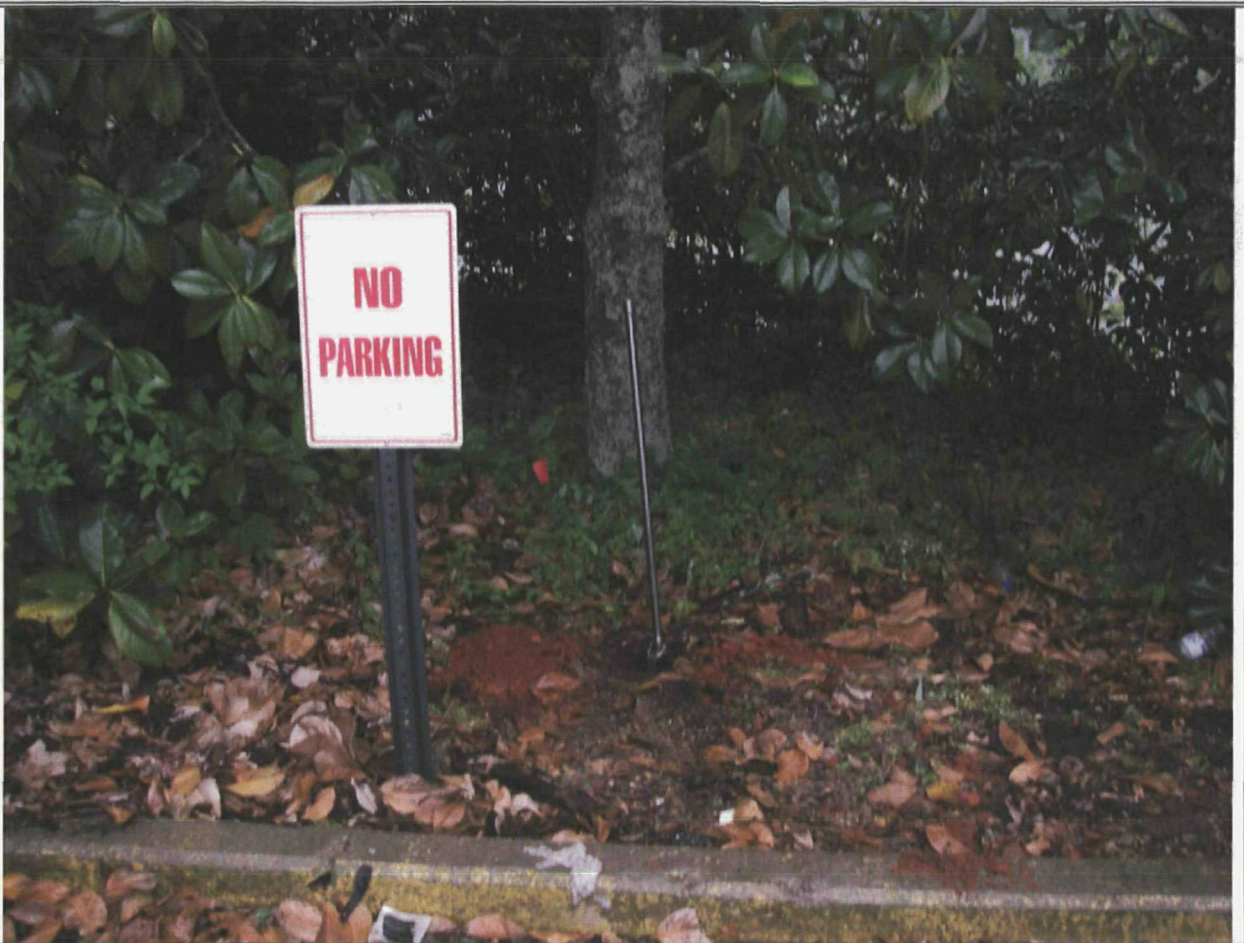
Depiction of immediate vicinity where surficial soil and sub-surface soil samples were collected from on-site Sample Station Nos. STA-27-SS and STA-27-SUB respectively (HW11012 and HW11013 respectively).

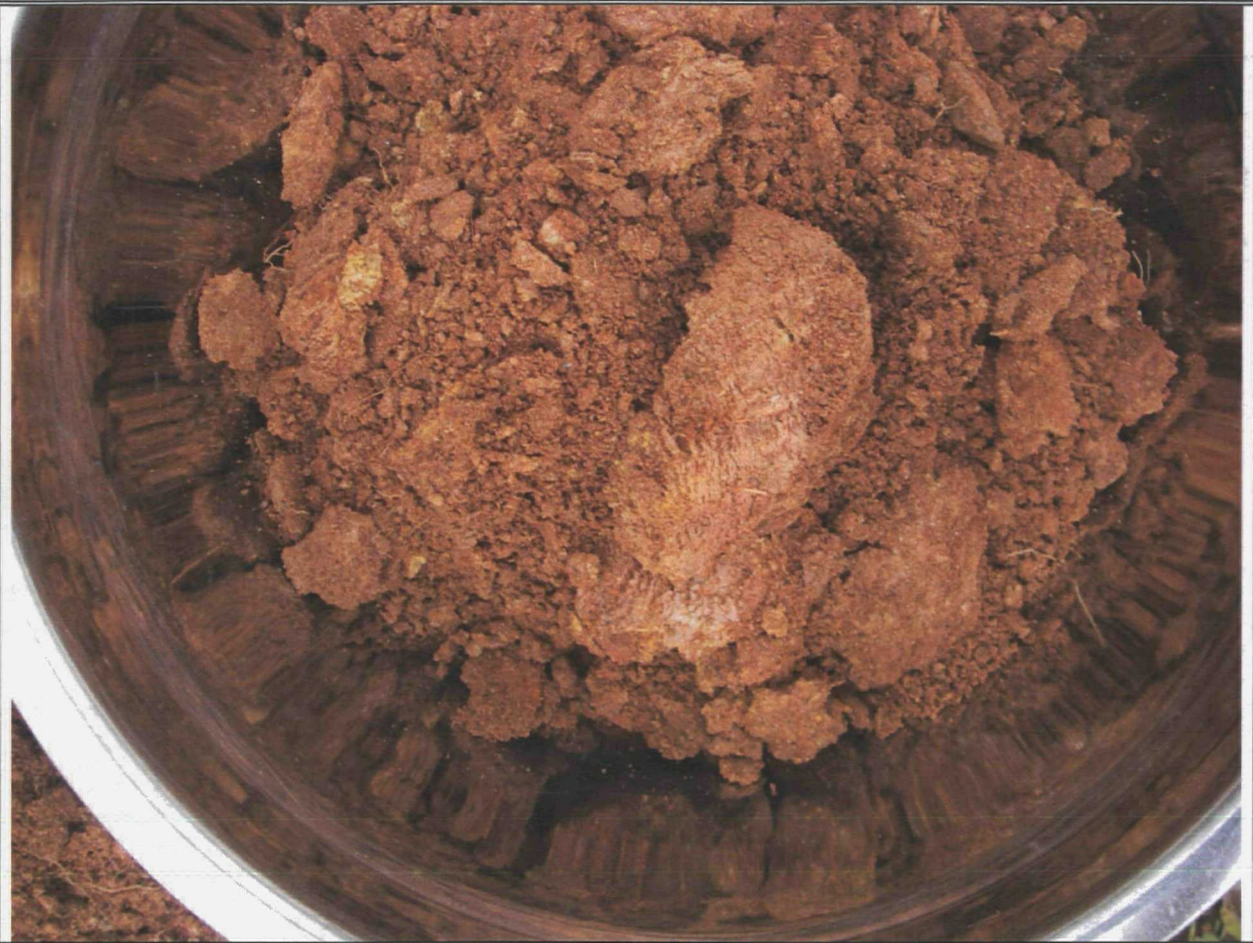
Depiction of surficial soil sample matrix collected from on-site Sample Station No. STA-22-SS (HW11005).

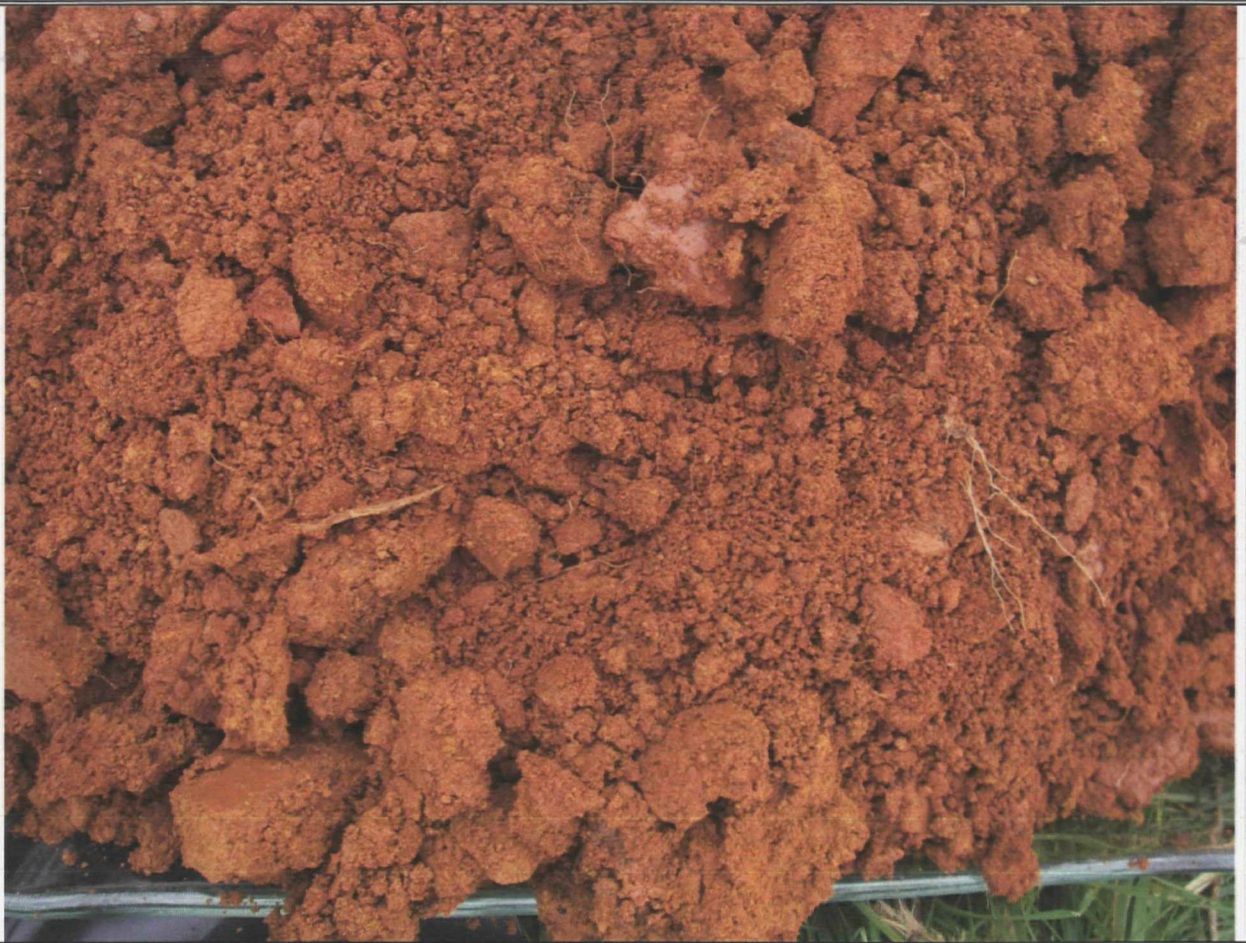
Depiction of surficial soil sample matrix collected from on-site Sample Station Nos. STA-24-SS and STA-24-DUP (HW11007 and HW 11008 respectively).

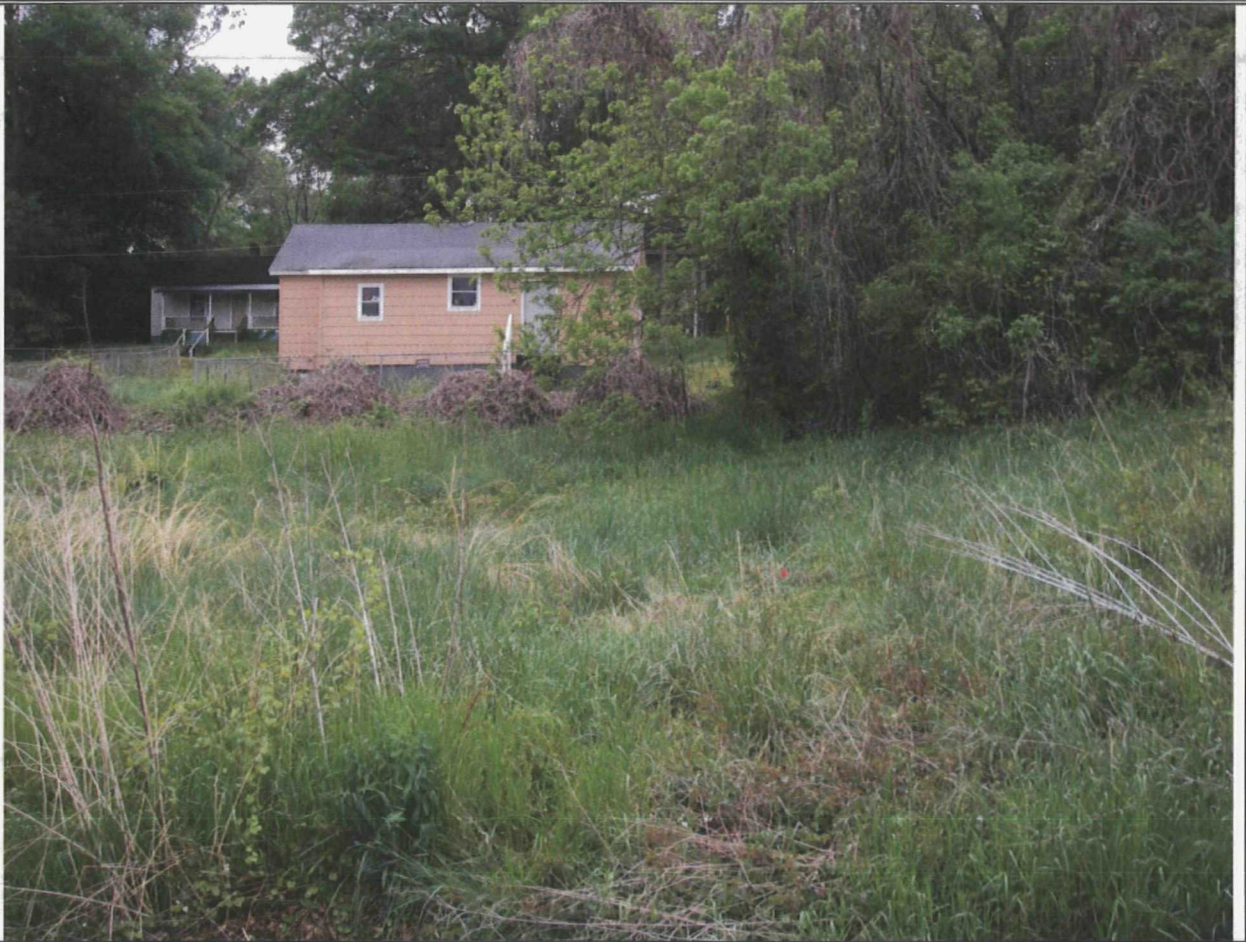
Depiction of general vicinity of where surficial soil samples were collected from on-site Sample Station Nos. STA-24-SS and STA-24-DUP (HW11007 and HW 11008 respectively).
